Activating water sensitive design for New Zealand

ALBANY, AUCKLAND FIELD WALK

WSUD walk: Albany

WSUD Albany Sites visited

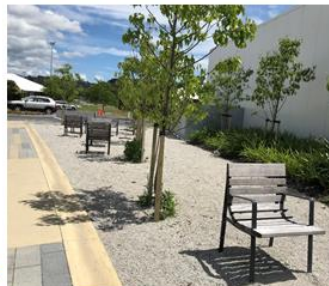
1 - Aquatic Stadium Permeable surface: [Hoggin](http://www.hoggin.co.nz)

1 - Aquatic Stadium: Hoggin

Hoggin is a compactable groundcover made from a mixture of clay, gravel, and sand or granite dust that produces a buff-coloured bound surface. In Auckland Hoggin is typically limestone GAP6 (<6 mm diameter) 'increasingly used as a low cost and environmentally friendly alternative to concrete and block paving'; it should be underlaid with coarser material if it is designed to provide drainage; compaction affects permeability; control of runoff concentration /slope is important to avoid scour (Wynyard Quarter hoggin scoured into raingardens and areas with very low permeability).

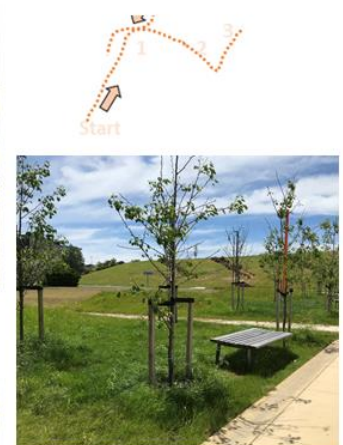
2 - Fruit trees amid topsoil mounds with infrequent mowing

2 – Trees amid topsoil mounds with infrequent mowing

Mounds create visual interest, enhance separation of areas, slow through traffic (especially if wheeled), and, if made from topsoil, increase water storage/availability for trees, but the trees should be planted on the sides of mounds (not in between as here) – greater topsoil depth is an effective way to increase tree resilience where subsoils are physically degraded, as typical across this area. These could be fruit trees, if higher and specialist maintenance (pruning) and removal of ground-fall fruit was built into maintenance. These costs might be offset by reduced mowing which also allows herbs to flower, providing food for predator insects and honeybees. A formalised orchard is also planted on the southwestern banks of Albany Lake to connect with historic European harvests.

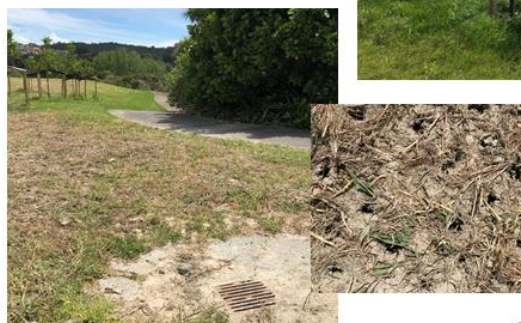
3 - Clay coring to increase infiltration on compacted park

This area of grass is compact clay and has been cored (solid or hollow tines placed into soil to about 50-10 mm depth) to increase infiltration, aeration and bearing capacity, allowing mowing with less rutting or bogging the mower. However this is unlikely to be effective because the soil is compacted right through the profile and water cannot run sideways (low slope and compacted topsoil) and it cannot go down; filling the holes with sand would also be largely ineffective. Bad soils suit a low-mowing strategy as taller grass transpires more water and compacting risk is reduced by physical cushioning and less frequent trafficking (allowing recovery) between mowing cycles.

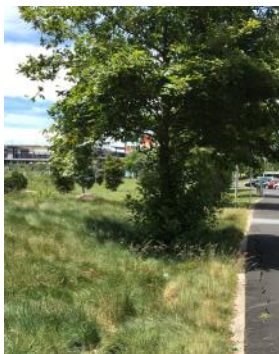
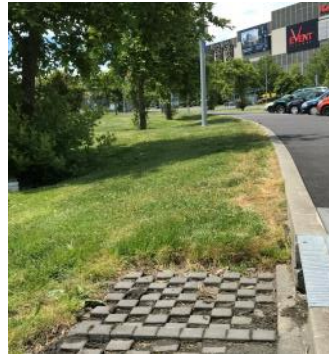
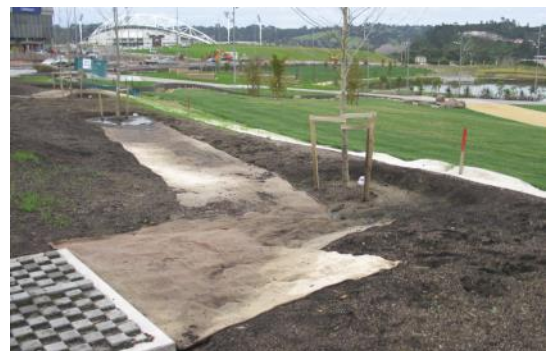
7 – Ponds with forebay, stage and amphitheatre (completed 2009, \$10.6M)

Kahikatea are included in areas around the lakes to reflect historic Maori use of area for harvesting of berries; flax cultivars for traditional weaving were to be planted on the north-western banks through Judy Te Hiwi (Pa Harakeke). Rocks are safe roosting areas for cormorants; avoiding mown lawn discourages mallard ducks and geese. The lakes were originally for Stormwater treatment but an amenity overlay was added (this multi-functional approach was also used at the younger Westgate park development except topsoil depth there is inadequate, not 300 mm and some trees that require better drainage, like puriri and titoki are dying).

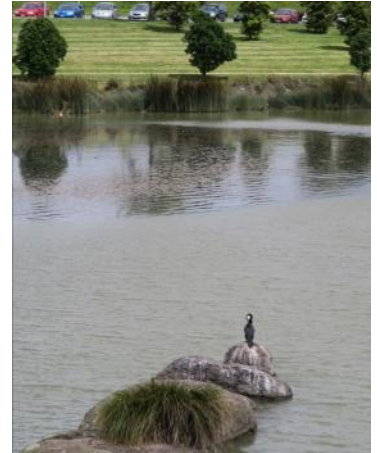
8 – Overflow from detention ponds through no-mow shrubland

The plantings in the park were conceived as the ‘heart and lungs’ to nurture and soften surrounding development and provide connections to the natural environment. This overflow area connects through to riparian area and Lucas Creek; it requires much lower than traditional mown lawns in parks, but does require weed removal; plant growth may be limited by low-quality soils. Note the bird on the rock!

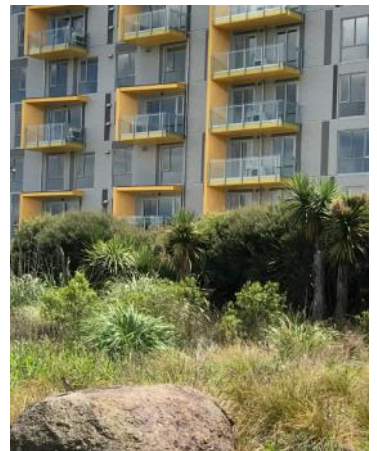
9 – Newly-planted bioswales/landscaping

The gardens lie within permeable Hoggin and intensively irrigated and mown lawns; some may act as bioswales and receive runoff; the areas were planted recently – a time of year that means plants are highly susceptible to drought stress. This will be an interesting area to watch over the next few years. The construction is adjacent to an area contractors’ park which has several large raingardens with single (deciduous) specimen trees...

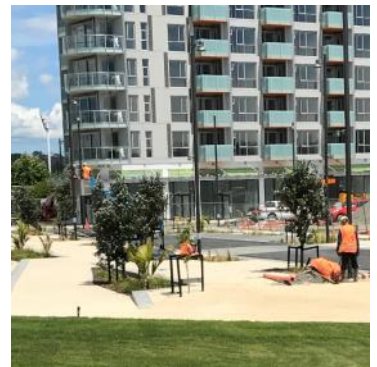
10 – Abandoned, rubbish-filled raingardens with unpruned trees

The raingardens have supported healthy tree growth but an absence of maintenance is evidenced by: large volume of gross litter; no tree canopy lifting which is needed to allow the groundcover plants under the canopy to remain dense; sediment accumulated in inflows; weeds growing – particularly on inlets; construction material and road signs in the raingardens. The raingardens on the side furthest from the construction was inundated by sediment runoff from bare land in about 2014, and this created excessive (days) of ponding.

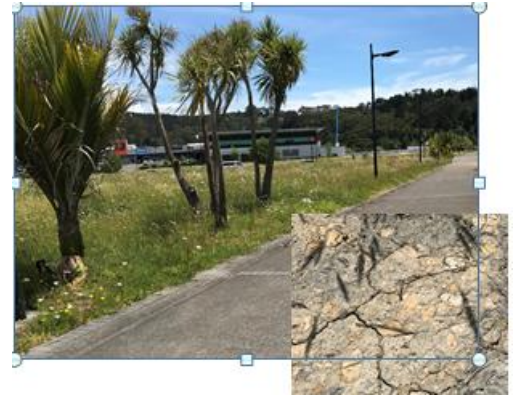
11 – 2007/9 landscaping struggling in local respread topsoil

Cabbage trees are highly tolerant of exposed conditions, as are nikau once established – but even these species are struggling in the very shallow topsoil – look for the place where the surface is exposed and look at the cracking and lumps of pale coloured which indicates hostile physical conditions.

Cabbage trees can cope with pruning back, and dead libs have been removed to tidy them up (they could have been given an organic mulch with 30% compost in the mix). Note the path is lower than the landscaped area in general.

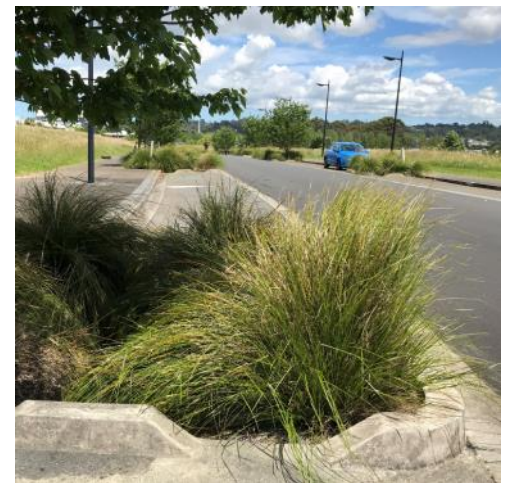
12 – Raingardens and separate tree pits with highly fertile media 2008

Cast *in situ* concrete frames form the outer skin of these raingardens and tree pits. Inlet location with road shape means only a few inlets ‘do the work’. Raingardens are visually indistinguishable from tree pits and landscaped areas except raingardens had denser plant growth due to more water and less drought stress when establishing in dry 2008/2009 summer and higher fertility, more air in winter. High fertility has resulted in sedges dominating (NZ iris *Libertia* and oioi *Apodasmia* have been smothered) and edges requiring cutting to maintain inlet function and road visibility. Once tree pits are full they overflow to raingardens or standard catchpit. Overflows are placed inside raingardens and have decorative flat tops, not nasty domes. These raingardens have a high proportion of treatment volume and low volume of concrete compared with earlier raingardens (stop 14). Media had high proportion of compost (c. 40% v/v) – localized piping / preferential flow can be seen where the media is inadequately compacted due to concrete outcrops) and there has been shrinkage/significant depth reduction. Organic mulch was used and shifted in some gardens initially.

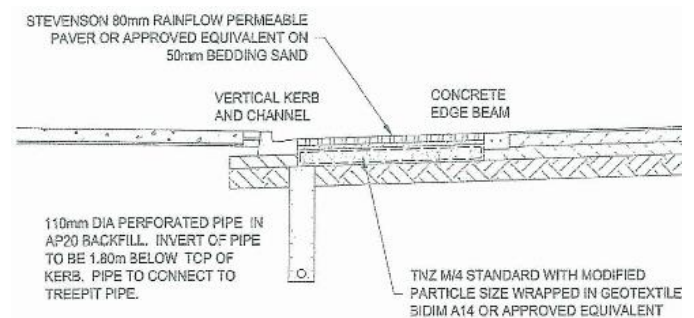
13 – Permeable paving

Stevenson 80 mm ‘rainflow’ permeable pavers are placed on 50 mm bedding sand and modified porous base course. Permeable paving is vulnerable to sediment running from adjacent earthworked areas during adjacent later building construction. Areas receiving shade have substantial adventive plants (including cosmopolitan native species).

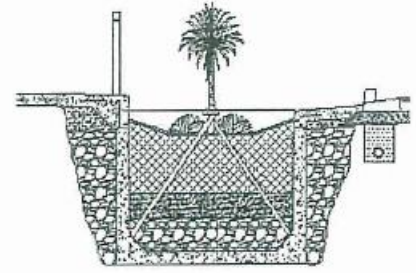
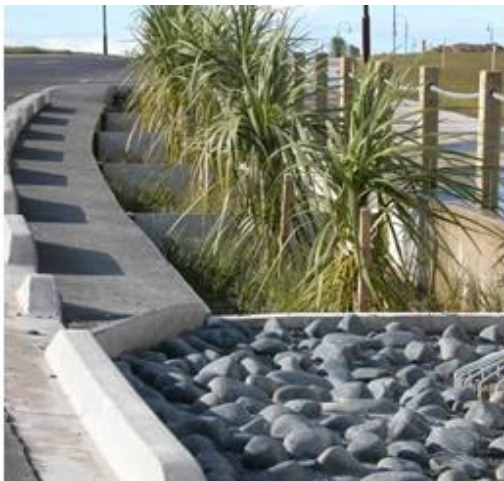
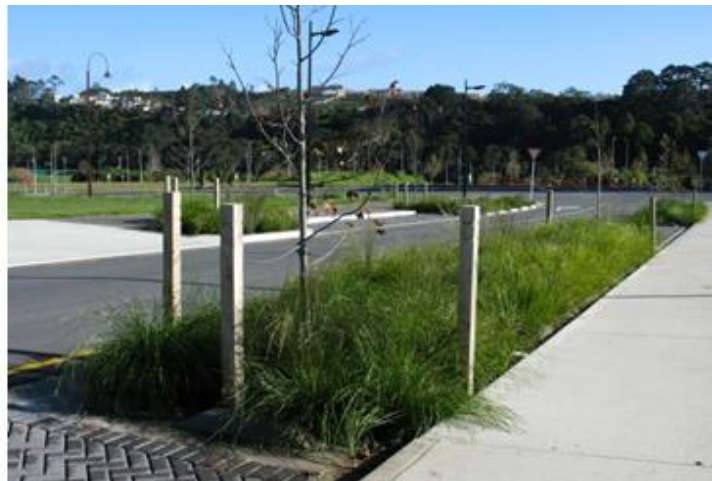
14 – Oldest raingarden ‘bear pits’ in ‘U’ concrete culverts 2006

These were designed a/c to TP10 (2003) to remove 75% TSS and erosion control for 1 yr ARI (65 mm depth over 24 hours); the local pipe system is designed for the 20 yr ARI. Excess Stormwater is directed to adjacent roads. They are grossly oversized for such small catchments with excessively wide concrete edges between road and raingarden (that create lovely sheet flow); excessive entry aprons; very large and ugly overflows outside the raingarden that cannot be masked with vegetation; and very deep ponding (originally 300 mm) created by baffle boards – contrast with the younger raingardens on Davies Road that have much larger ‘treatment volume’ to concrete ratios. Pebble mulch. The bollards and chains that protect people from the bear pits add maintenance cost and risk.

Cabbage tree and sedge survival is variable; initial vandalism of cabbage trees may have been exacerbated by rope & stake supports; plant ground cover is now marginally adequate. The single species used, *Carex secta* is vulnerable to Roundup drift. Media is typical ‘TP10’ with relatively high fines content and low to moderate organic content (described as ‘loam/sand media on coarse sand transitional layer on gravel drainage).

Corban Ave raingardens in 2006 shortly after installation; Davies Road raingardens at about 12 months of age (2009)

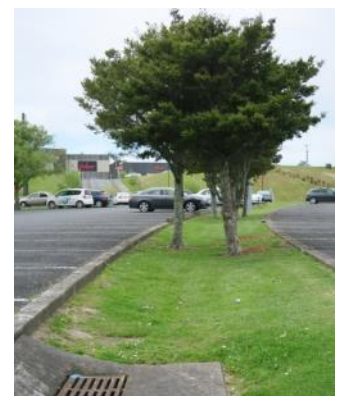
16 – Carpark mown grass and tree swales

These swales are old but low maintenance; clustered trees boost stormwater performance through increasing Evapotranspiration T, functional soil depth as roots extend, also increase aesthetics and provide service of reducing reduce parked car temperatures. Native trees can provide habitat (fruits of totara, bark and insects are important for native animals) but all trees are vulnerable to collar damage from weedeaters; permanent ground covers

are better than mown grass. The grass is typically mown too short (much less than 100 mm height), however a relatively dense grass cover and absence of over-sprayed areas around grates is avoiding creating bare areas.

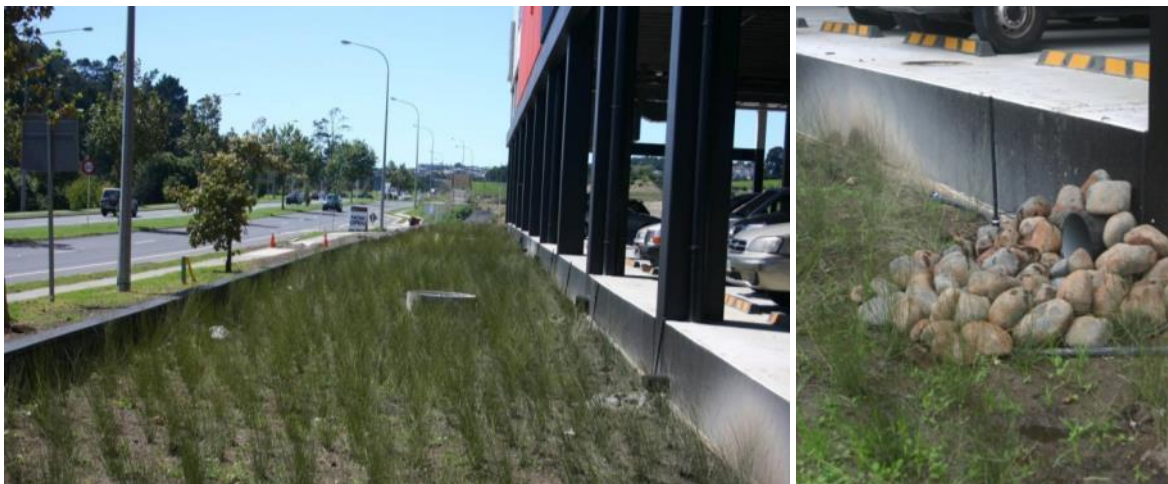
Mitre 10, shortly after construction (c. 2009/10?) and after retrofit of rocks at inlet pipes (right – photos courtesy Chris Stumbles). Raingarden and landscaped area had different soils; raingarden mix was free-draining with reasonable bearing capacity but weedy to start with (no mulch); mulched landscaped area had ponded water and very low bearing capacity

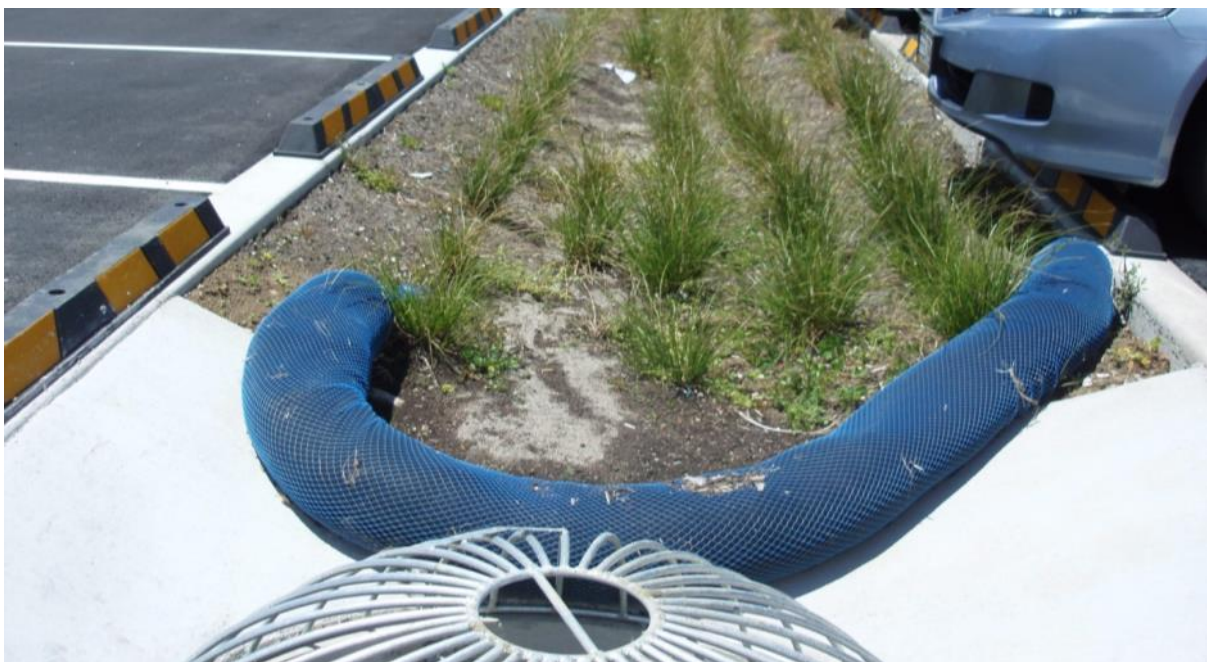
Park n Ride swales (2012 photo – should not plant in straight lines like this)

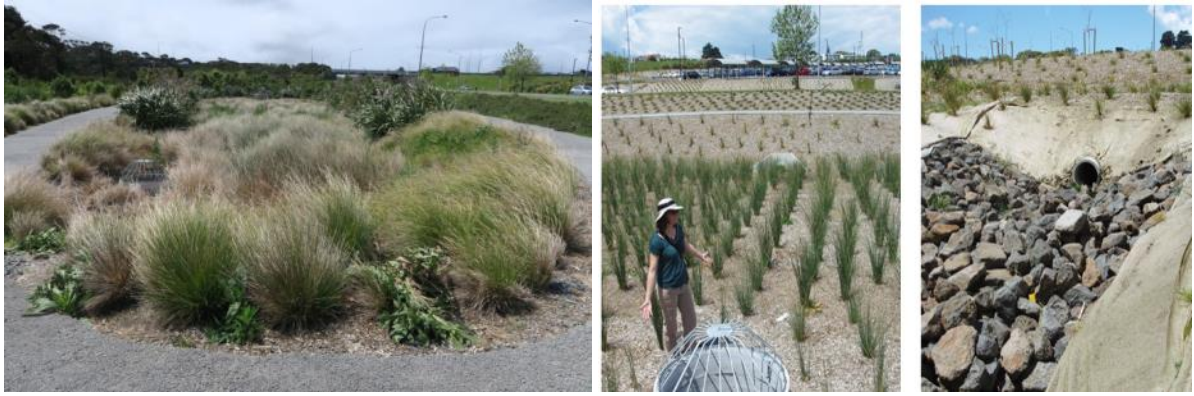
Albany park and ride station large raingarden (part of treatment train). Right photos are from 2012 and show overflow and rock-lined outlet structures

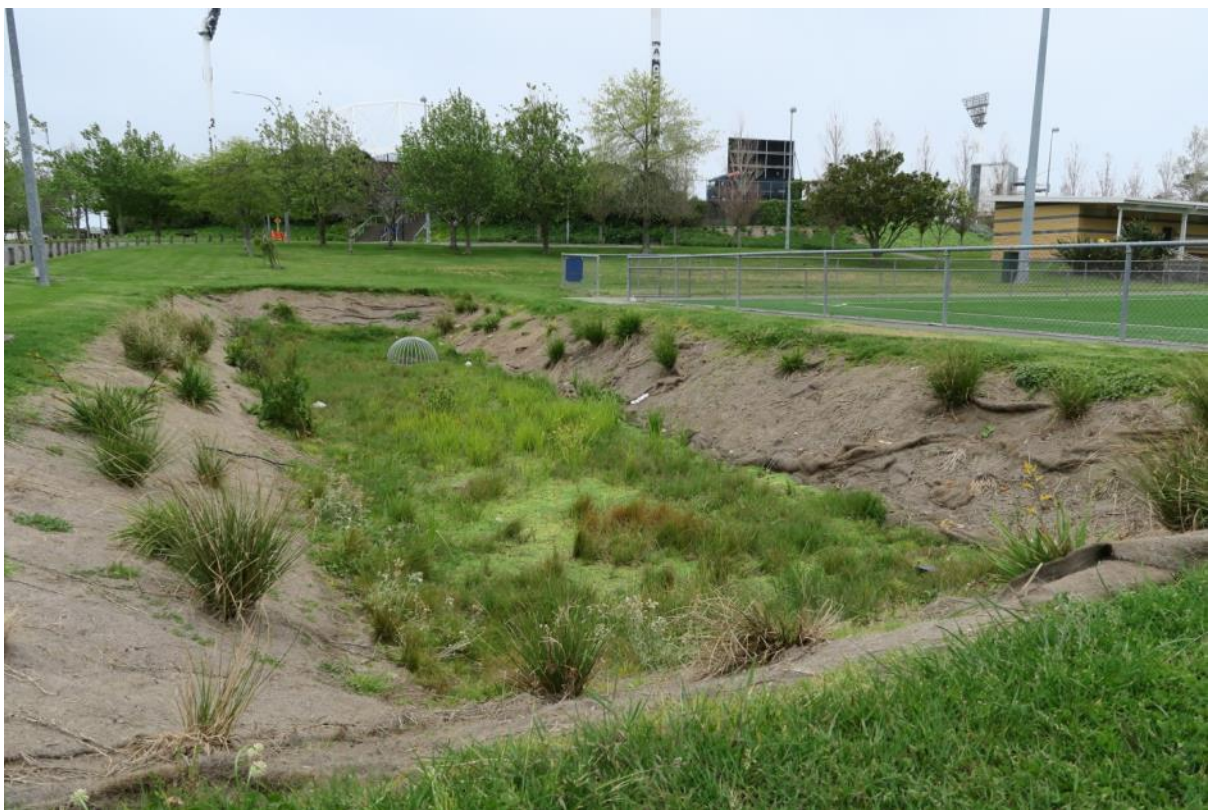
Ugly detention basin / raingarden receiving runoff from artificial turf: High maintenance, narrow benefits

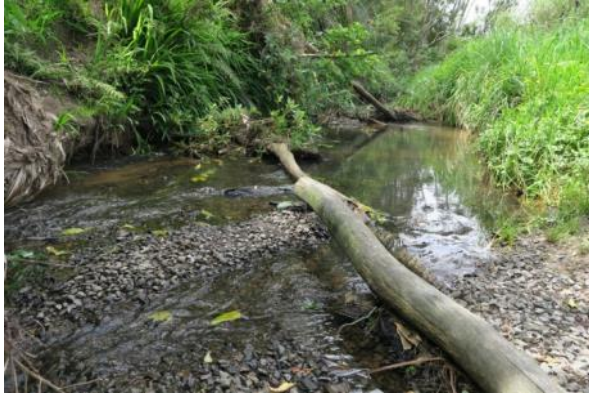
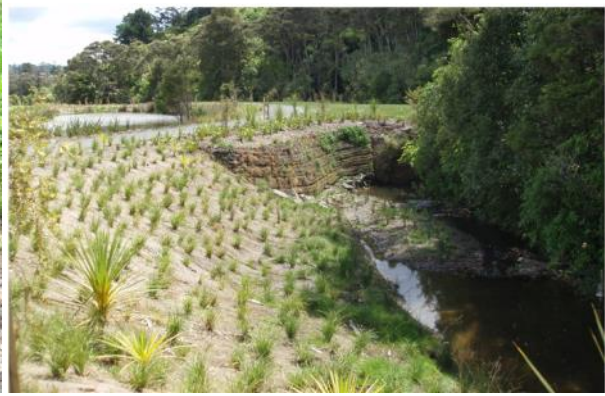
Lucas Creek reshaping of flood zone and riparian area to reduce erosion/bank instability by increasing floodplain width, adding habitat features (right photo is 2012)
