Activating water sensitive design for New Zealand

ALBANY, AUCKLAND FIELD WALK

WSUD walk: Albany

WSUD Albany Sites visited

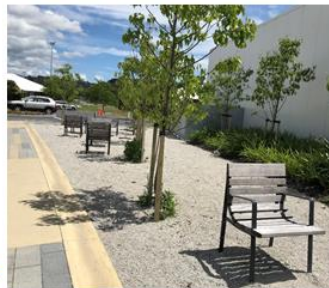
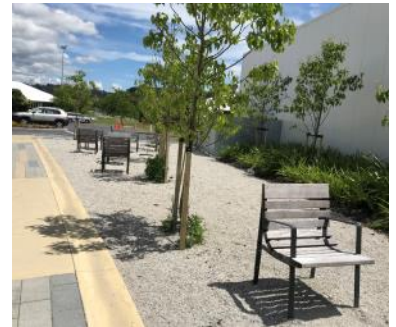
1 - Aquatic Stadium Permeable surface: [Hoggin](http://www.hoggin.co.nz)

1 - Aquatic Stadium: Hoggin

Hoggin is a compactable groundcover made from a mixture of clay, gravel, and sand or granite dust that produces a buff-coloured bound surface. In Auckland Hoggin is typically limestone GAP6 (<6 mm diameter) 'increasingly used as a low cost and environmentally friendly alternative to concrete and block paving'; it should be underlaid with coarser material if it is designed to provide drainage; compaction affects permeability; control of runoff concentration /slope is important to avoid scour (Wynyard Quarter hoggin scoured into raingardens and areas with very low permeability).

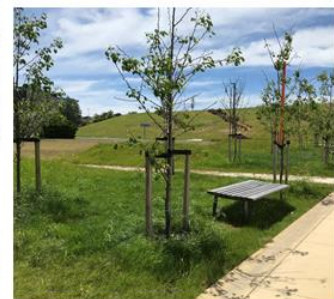
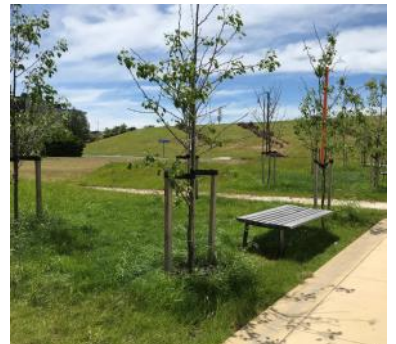
2 - Fruit trees amid topsoil mounds with infrequent mowing

2 – Trees amid topsoil mounds with infrequent mowing

Mounds create visual interest, enhance separation of areas, slow through traffic (especially if wheeled), and, if made from topsoil, increase water storage/availability for trees, but the trees should be planted on the sides of mounds (not in between as here) – greater topsoil depth is an effective way to increase tree resilience where subsoils are physically degraded, as typical across this area. These could be fruit trees, if higher and specialist maintenance (pruning) and removal of ground-fall fruit was built into maintenance. These costs might be offset by reduced mowing which also allows herbs to flower, providing food for predator insects and honeybees. A formalised orchard is also planted on the southwestern banks of Albany Lake to connect with historic European harvests.

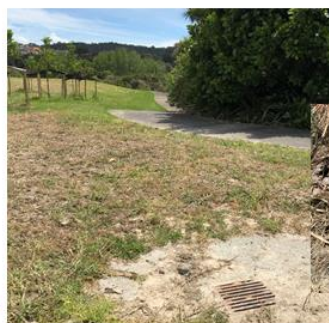
3 - Clay coring to increase infiltration on compacted park

This area of grass is compact clay and has been cored (solid or hollow tines placed into soil to about 50-10 mm depth) to increase infiltration, aeration and bearing capacity, allowing mowing with less rutting or bogging the mower. However this is unlikely to be effective because the soil is compacted right through the profile and water cannot run sideways (low slope and compacted topsoil) and it cannot go down; filling the holes with sand would also be largely ineffective. Bad soils suit a low-mowing strategy as taller grass transpires more water and compacting risk is reduced by physical cushioning and less frequent trafficking (allowing recovery) between mowing cycles.

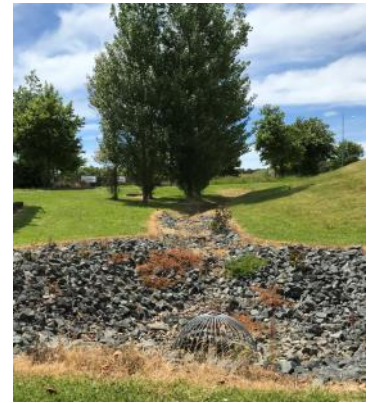
4 - Rock-lined detention area at end of major grassed swale

Ugly scruffy dome for highly visible site, no plants, herbicided weeds. Ugly, but narrowly functional as it is resistant to erosion, it is easy to check overflow is clear, and easy to maintain using glyphosate. Would have been useful to get a landscape architect involved!

Presumably installed prior to 2009 and not part of Albany upgrade.. above this site are the dreadful Westfield carparks where isolated landscaping trees are installed right beside catchpits and isolated from surface water (a huge missed opportunity).

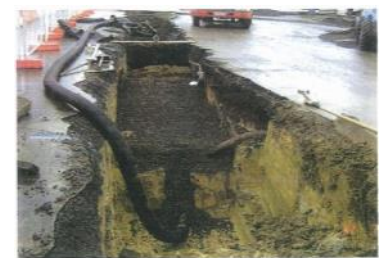
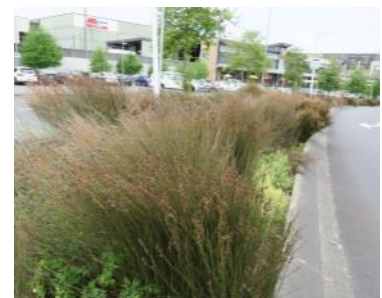
5 – No-mow road median bioswale with integrated trees, 2009

These extensive, central raingardens and swales extend along Civic Drive and form the first part of a treatment train. They were constructed in 2008/09 and designed to provide pre-treatment of water and reduction of stormwater volumes flowing into the Albany Lakes. The swale has 600 mm media depth which is increased to 1000 mm under trees with no change in surface level – an elegant way to save money and excavation (see photo). However any central median is expensive and disruptive to traffic flows to maintain if maintenance requires traffic controls to ensure safety of the workers.

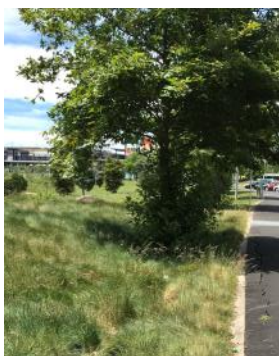
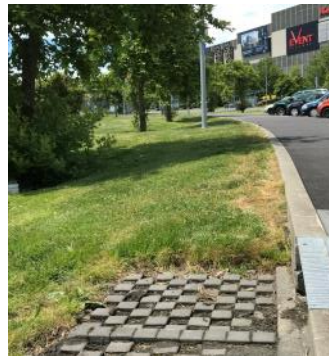
6 – Grass swales with integrated tree basins, 2009

Surface runoff from the road flows under footpath through wide (c. 400 mm) grates onto a robust but attractive concrete erosion pad. The width and drop help ensure that litter/clippings don't block the grates. In a few places the grates have been bent by heavy vehicles. Each inlet drains to two tree pits via grassed swales – during construction protection was provided by erosion cloth (photo below). Topsoil depth across the grassed areas and beyond is 300 mm – this supports more healthy, resilient grass and allows tree roots to spread out from the tree pits. 6A (left photo) uses a grass species that requires no/infrequent mowing (a *Festuca*) but is more expensive to establish ; 6B (centre photo) is a traditional, intensively-mown grass verge (deciduous trees). Large-leaved deciduous trees are used throughout, creating an unnecessary blockage risk and additional autumn maintenance.

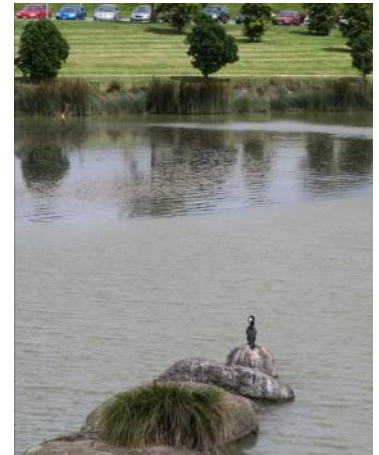
7 – Ponds with forebay, stage and amphitheatre (completed 2009, \$10.6M)

Kahikatea are included in areas around the lakes to reflect historic Maori use of area for harvesting of berries; flax cultivars for traditional weaving were to be planted on the north-western banks through Judy Te Hiwi (Pa Harakeke). Rocks are safe roosting areas for cormorants; avoiding mown lawn discourages mallard ducks and geese. The lakes were originally for Stormwater treatment but an amenity overlay was added (this multi-functional approach was also used at the younger Westgate park development except topsoil depth there is inadequate, not 300 mm and some trees that require better drainage, like puriri and titoki are dying).

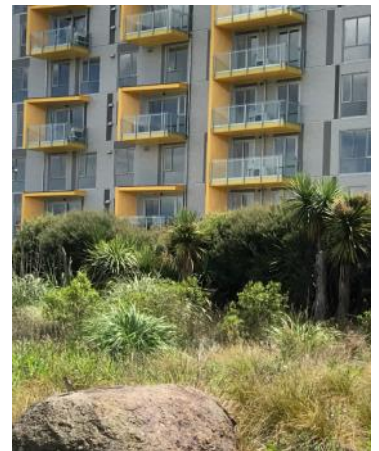
8 – Overflow from detention ponds through no-mow shrubland

The plantings in the park were conceived as the ‘heart and lungs’ to nurture and soften surrounding development and provide connections to the natural environment. This overflow area connects through to riparian area and Lucas Creek; it requires much lower than traditional mown lawns in parks, but does require weed removal; plant growth may be limited by low-quality soils. Note the bird on the rock!

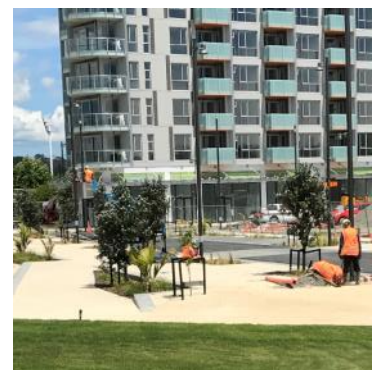
9 – Newly-planted bioswales/landscaping

The gardens lie within permeable Hoggin and intensively irrigated and mown lawns; some may act as bioswales and receive runoff; the areas were planted recently – a time of year that means plants are highly susceptible to drought stress. This will be an interesting area to watch over the next few years. The construction is adjacent to an area contractors’ park which has several large raingardens with single (deciduous) specimen trees...

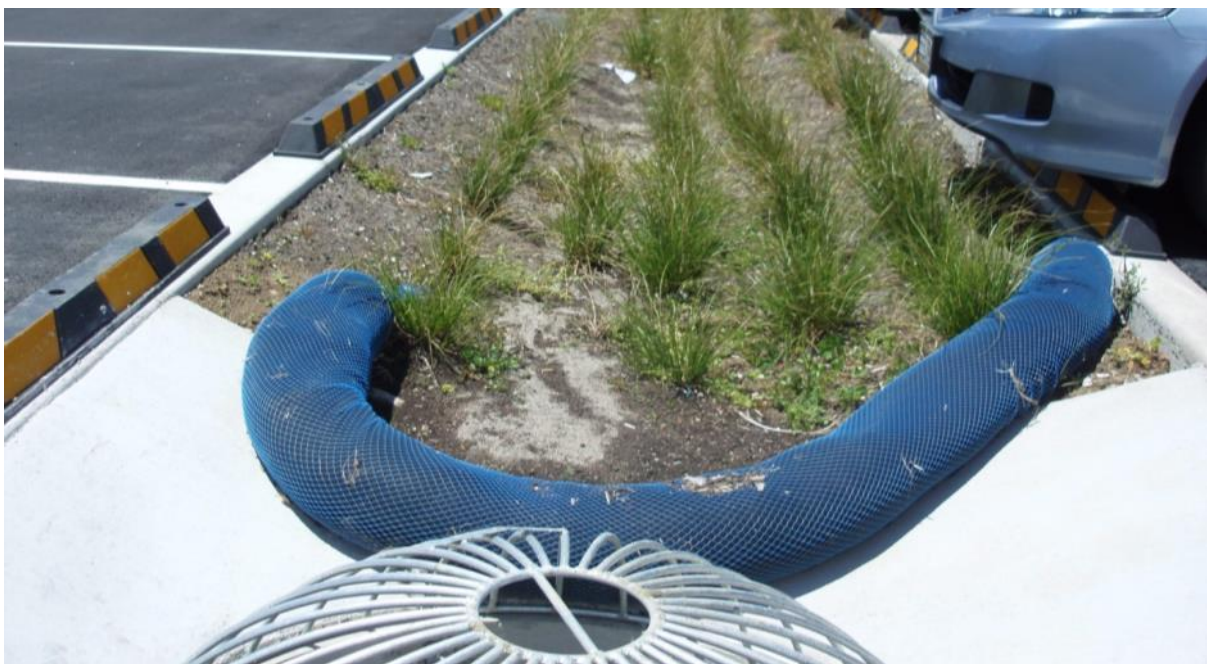
Park n Ride swales (2012 photo – should not plant in straight lines like this)

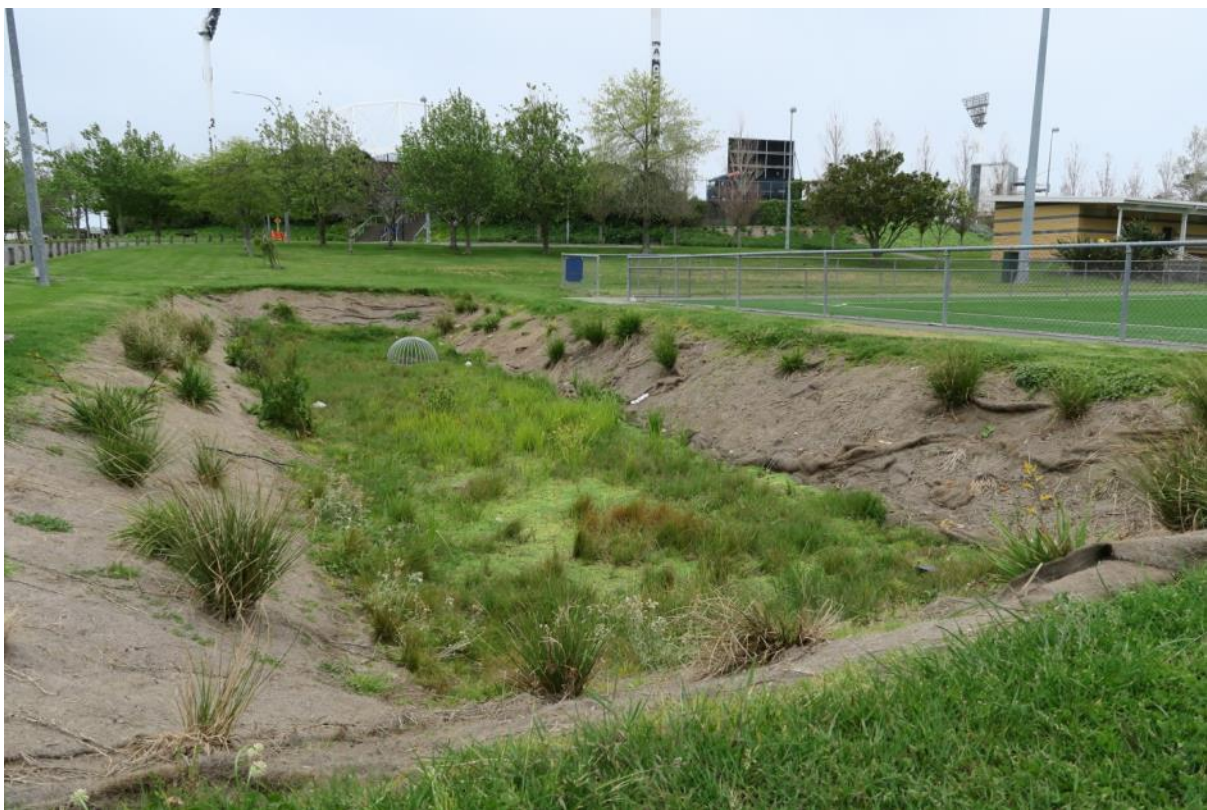
Ugly detention basin / raingarden receiving runoff from artificial turf: High maintenance, narrow benefits
