# WSUD Case Study: AMETI

AMETI Stage 1 (design 2011)

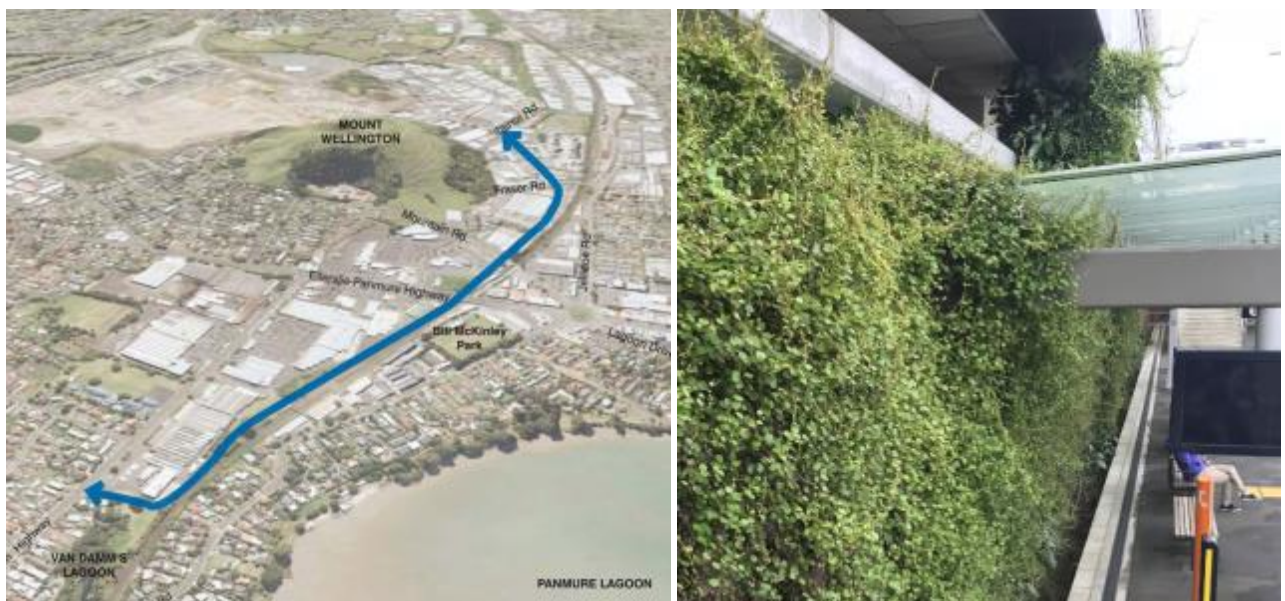
AMETI Stage 1 (design 2011) and green screen in stormwater planter boxes at the Panmure railway station (2018)

- Green screens within stormwater planter boxes show three native species have low maintenance costs and cover 3 stories within 5 years when provided with adequate root volume and water supply and light. The planter box width ensures no impervious surface below *Tecomanthe speciosa* so avoids additional maintenance (the large flowers are slippery when fallen on footpaths)

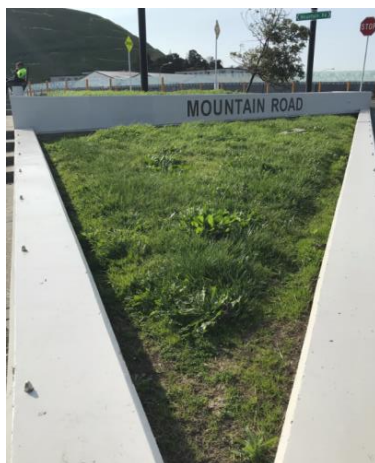
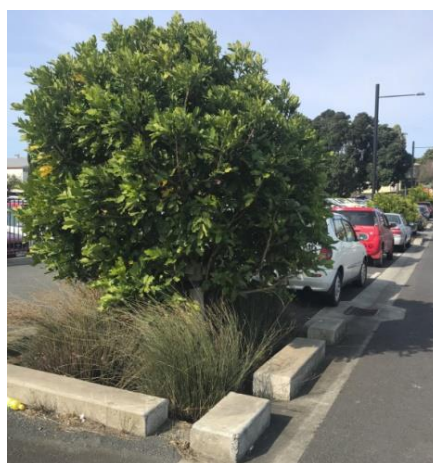
Turf platforms that are expensive to maintain (left); deep raingardens on Potaka Lane have healthy kohekohe trees that need trimming to retain sightlines, the wide inlets are resistant to being blocked by sediment and easy to clean but some are redundant (centre); these grassed areas on Quinlan Street cannot be mown so are maintained with regular herbicide sprays that creates poor aesthetics.

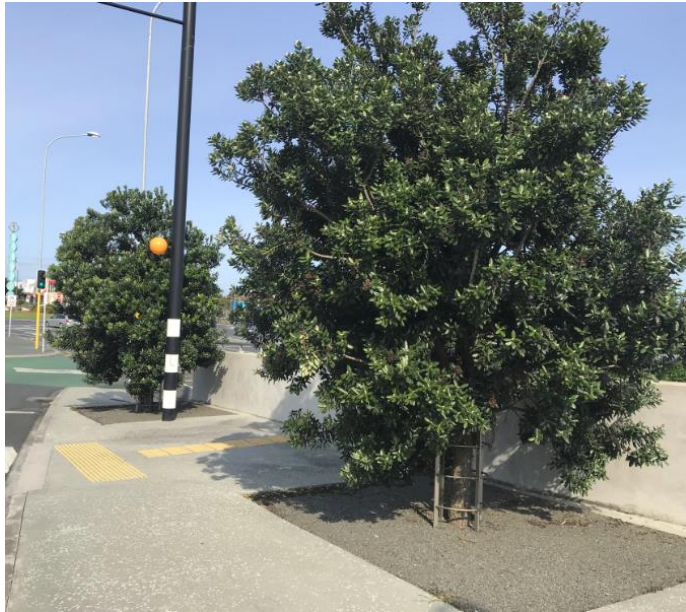
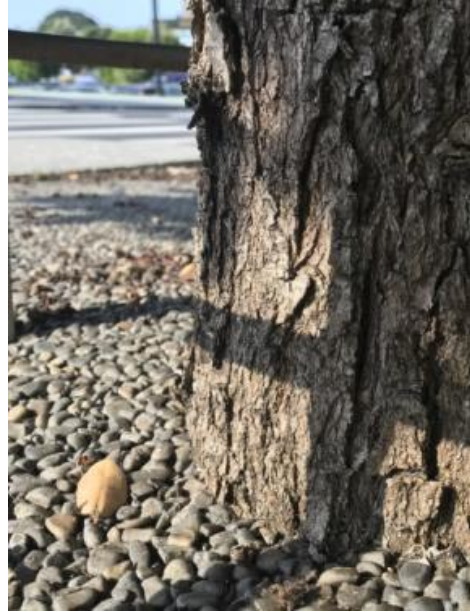
Tree pits with poured-resin permeable paving could have been used to treat road runoff (left); the resin needs regular removal to avoid ringbarking the growing tree (right)

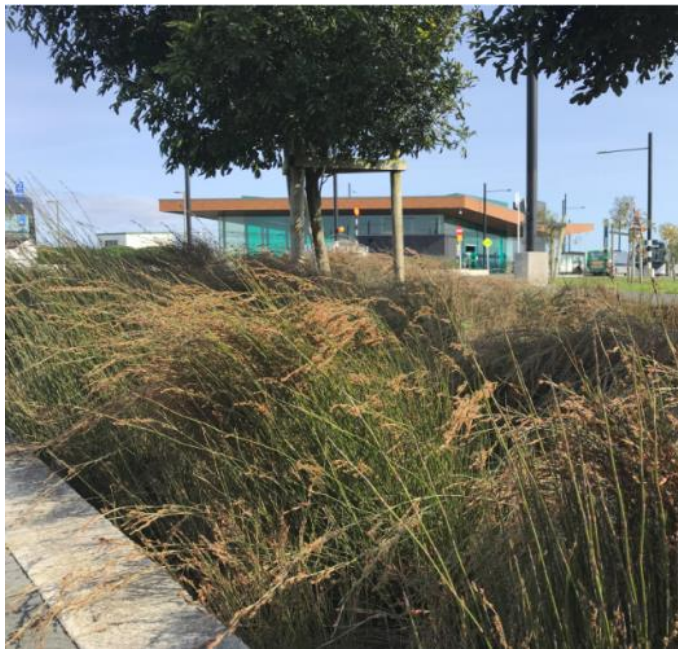
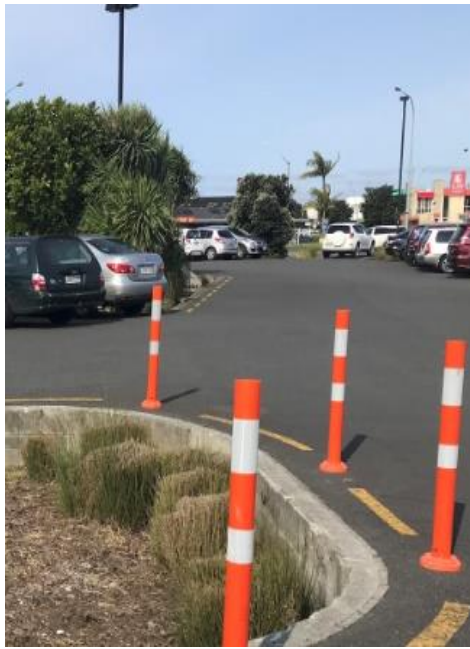
This large raingarden with healthy titoki trees adjacent to the bus station has low maintenance due to dense groundcover and relatively large core relative to edge (left); trees in this small 'island' raingarden in the park and ride have died; surviving oioi groundcover (sedges were inadvertently killed by glyphosate spray) has been over-trimmed, exposing large areas of bare soils (right)

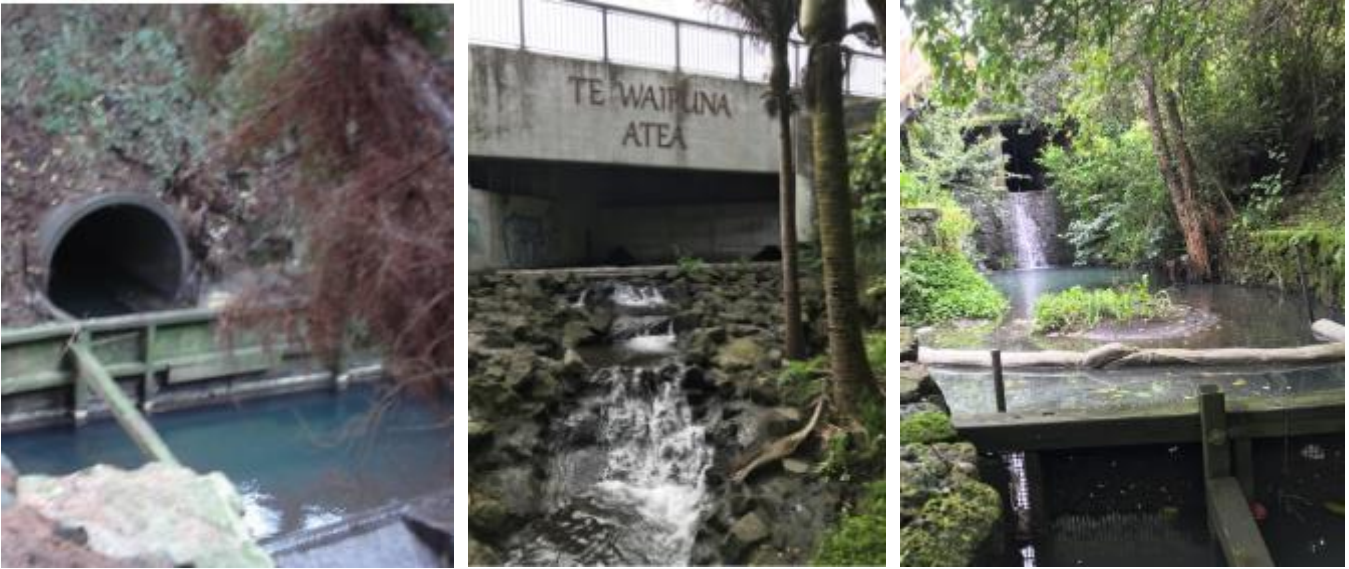
Inlets in 2010, before works (left) and after works in 2018 with naming, waterfall and hidden energy dissipation structure under the bridge (centre). A second inlet has stonewalls flanking a litter screen and oil & grease bund, both of which require regular maintenance to minimize short-circuiting (right)

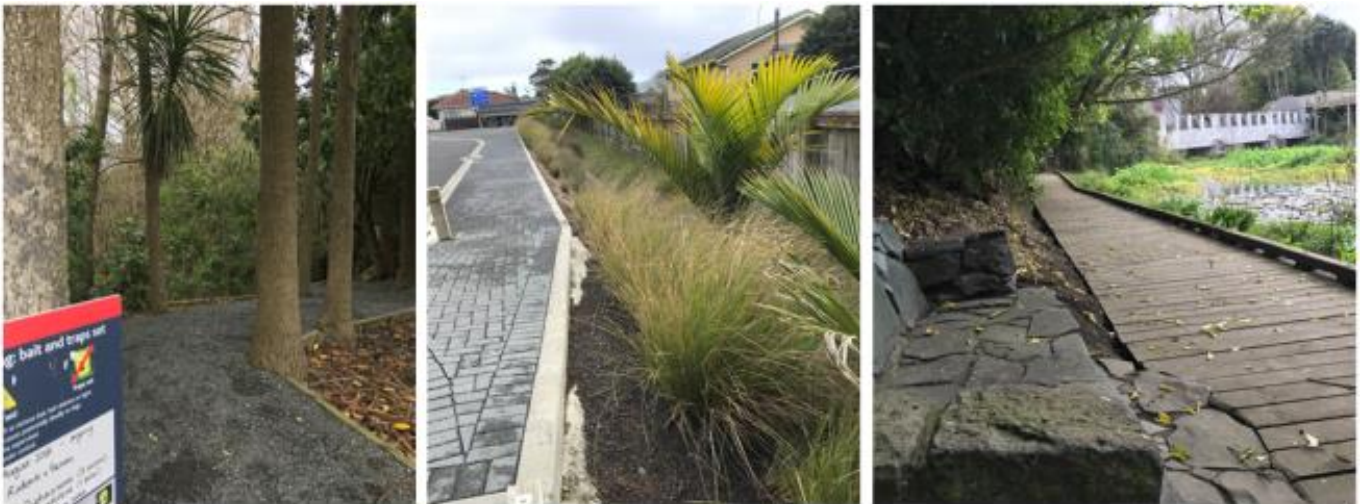
Permeable gravel surface at an entrance to Van Damm's lagoon minimise damage to existing ti kouka (cabbage trees) (left); a swale at the carpark uses native sedges (centre); a broad boardwalk has improved safety and sewer is covered (right).

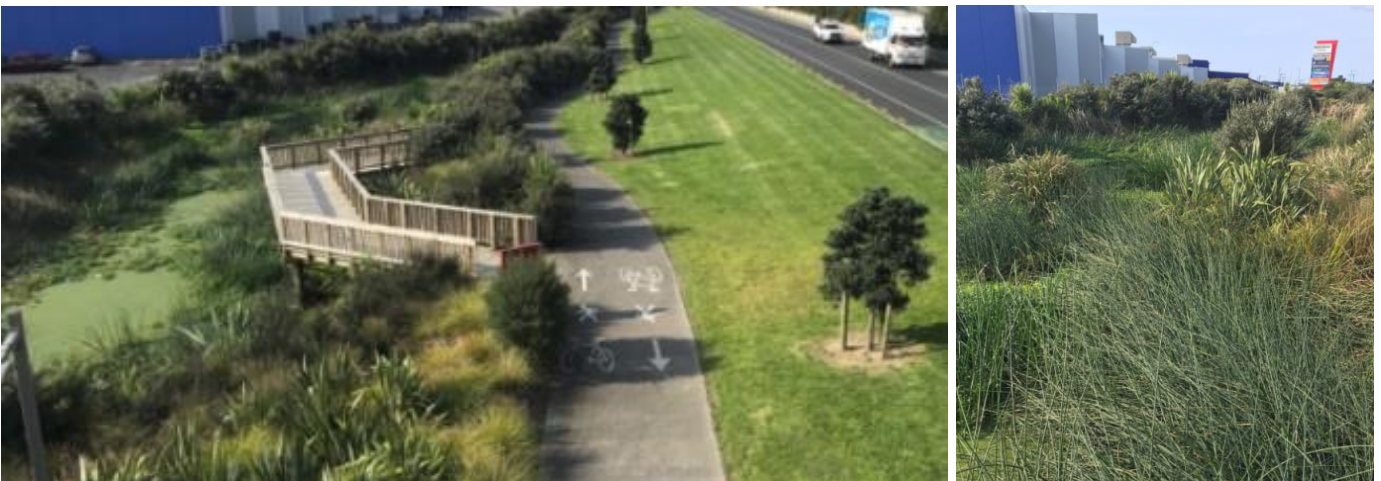
Horoeoka Road wetland and pond with viewing platform and extensive native planting (left); and wetland close-up (right)

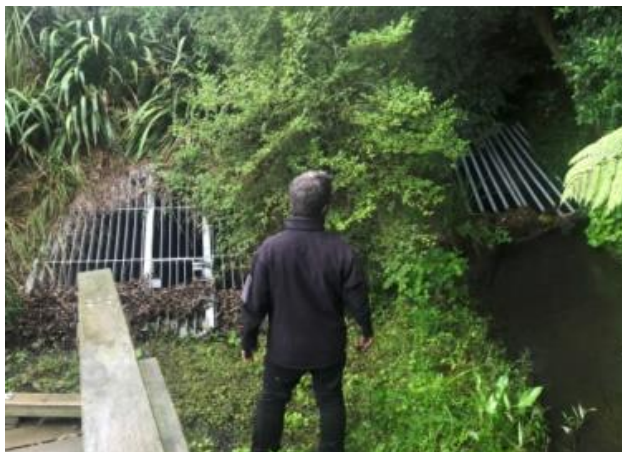
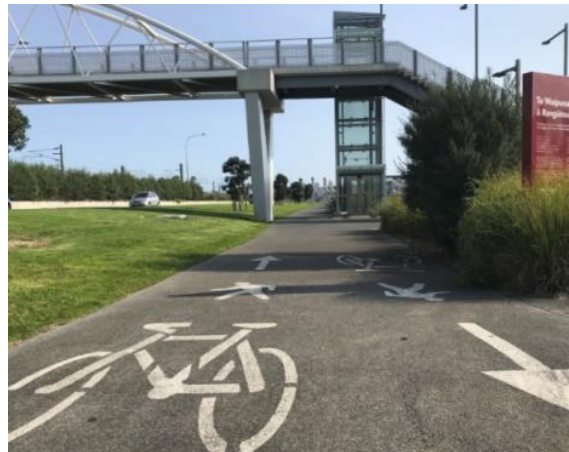
A new outlet under the railway reduces flooding (left); the new road provides for cycling and walking (right)

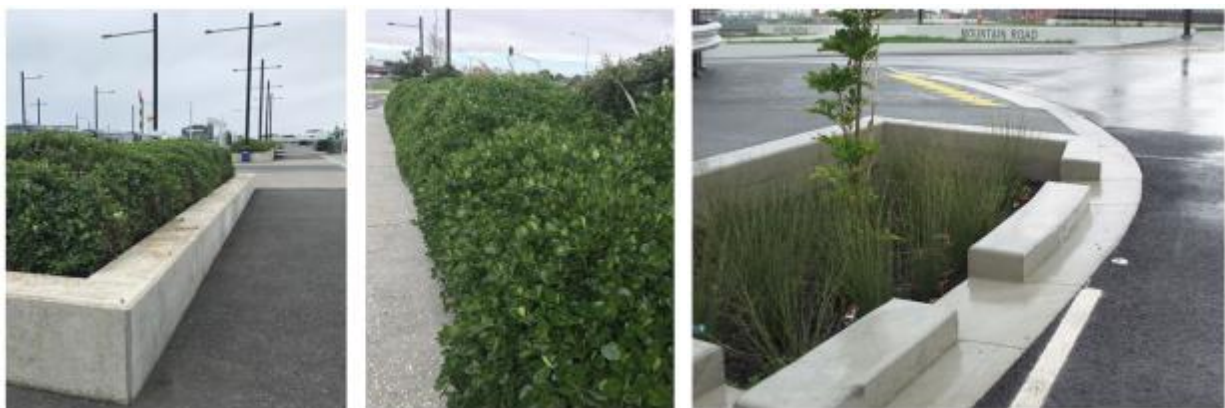
Broad concrete edging of planter boxes creates seating at the bus station where plants when trimmed within the edge (left), and prevents seating where plants reach the ground but creates a larger 'mass' of green in this otherwise hard urban landscape. Inlets to street tree pit raingardens are broad and even, so unlikely to block (right)

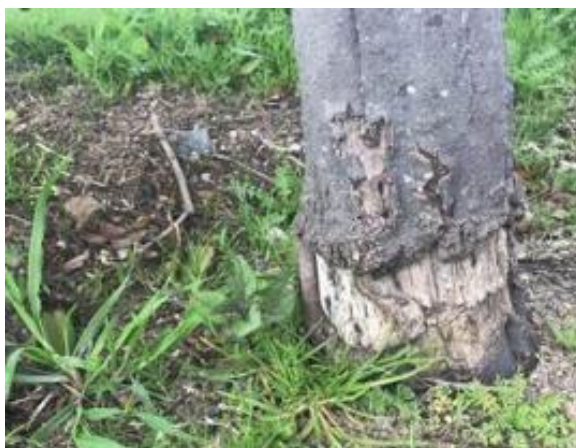
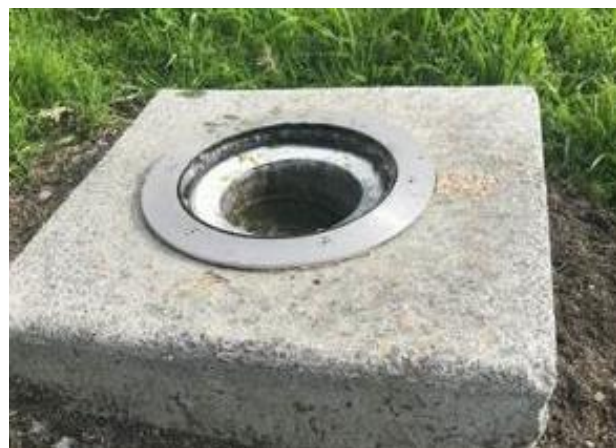
Severe damage from 'weed eaters' to the base of this titoki tree in a grass area shortens tree life and stability as it allows rot to enter – this tree should be replaced (left). Up-lighting placed in grass or planted areas require additional specific edge maintenance, increasing cost; this one has been broken and is flooded (right)

- Use of weed-eaters or weed-whackers around trees unless trunks are physically protected by a resistant barrier.
- Lack of reactive maintenance. Stressed plants can often be 'retrieved' if stress is removed early enough, for example, saturated raised garden beds can be fixed by replacing broken irrigation or an obstructed outlet. Maintenance checklists should identify over-sprayed, dead and bare areas to flag the need for reactive mulching, replanting and/or other actions. It is important to identify why plants died, e.g. compacted soil may need loosening or placement and larger plants used to discourage pedestrians; where water scour has removed mulch, a heavier stone mulch may be needed.
