# Green Roofs - WSUD Case Studies

Two green roof case studies are presented in this fact sheet:

## Mt Difficulty Living Roof

## Remarkables Primary School Living Roof

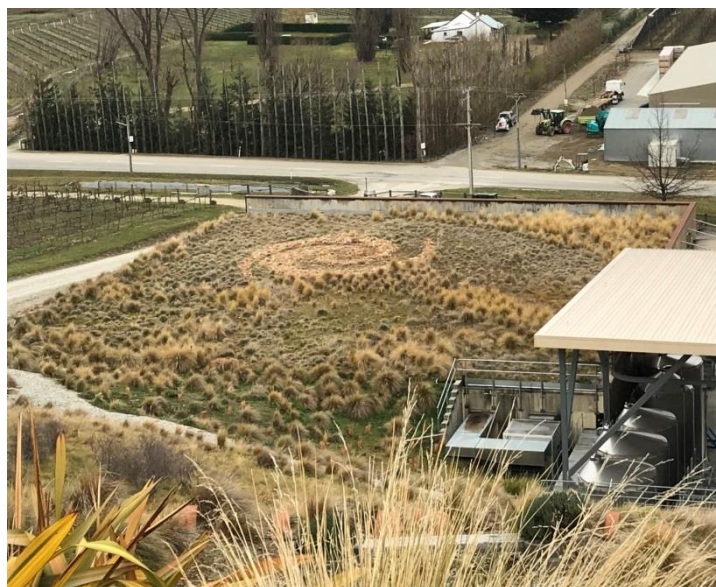
- Approximately 900m<sup>2</sup> in size, 1:60 slope.
- Original plants: short and tall native tussocks (*Festuca coxii* and *Poa cita*), locally-sourced (wild) sedums and thyme (non-native)
- Growing medium: 150 mm deep, light-weight pumice, zeolite and compost conforming to internationally-used FLL green roof permeability standards.
- Drainage built into module design (no additional under-drainage required); 450 mm wide perimeter drain filled with local river-rounded gravels with separation from modules by stainless steel slot drain.
- EcoTuff TPO waterproof membrane on 90 mm concrete.
- Parapet or steel handrail in all places where fall from roof is more than 1 m height.
- The roof is irrigated with process water to provide evaporative summer-cooling for the wine store.

The Mt Difficulty Living Roof is a pre-grown, modular roof (LiveRoof) made from about 4800 modules filled with 150 mm deep, light-weight media. It was installed by Stormwater360 in March 2012. The tussock-dominated roof covers the barrel hall (wine store) at **Mt Difficulty Winery**, Bannockburn, Central Otago, New Zealand<sup>1</sup>. It was designed to provide evaporative cooling to maintain optimum temperatures for the wines beneath.

The green roof is a modularised “Living Roof” product supplied by Stormwater360. Modules were pre-grown in a local nursery and trucked to site<sup>3</sup>. The rigid plastic edges of modules interlock, so were also used to instantly cover and stabilise steep slopes between roof and adjacent road. Temporary edges around each module are removed during installation, allowing roots to grow from tray to tray, forming a resilient, integrated surface.

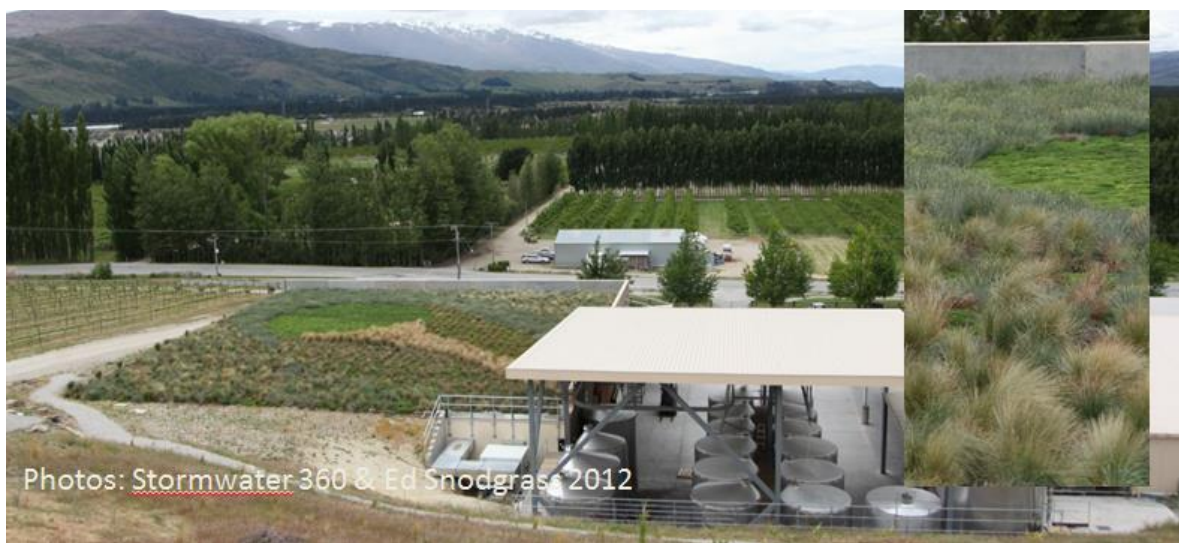
**Mt Difficulty roof after about 12 months when thyme was still a dominant feature**

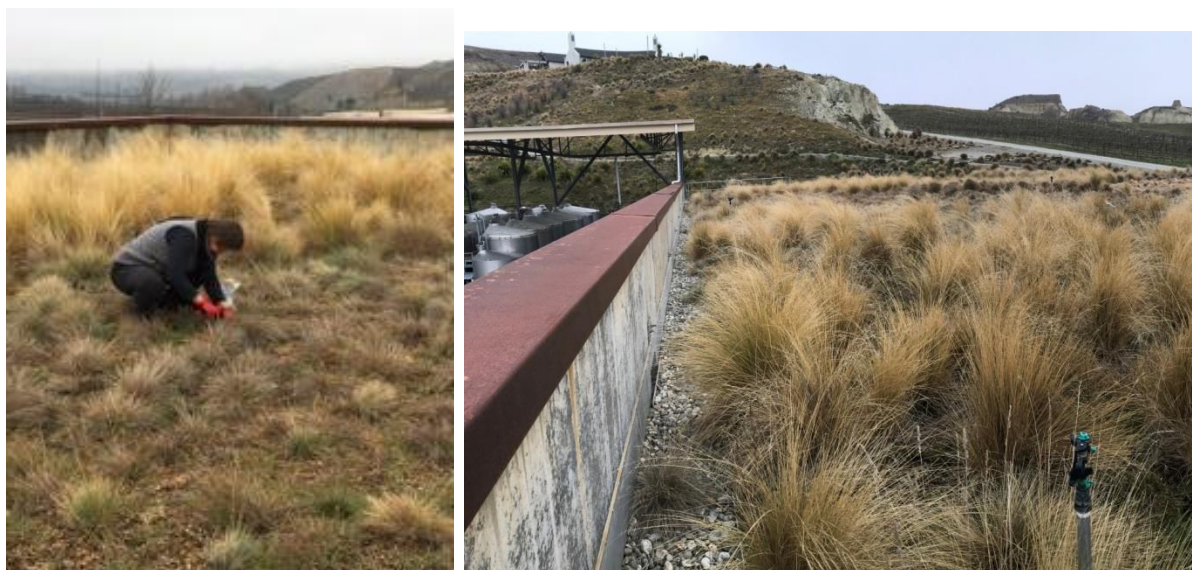
**Mt Difficulty roof at age 6.5 in early spring before sedums flower; the right photo shows the gravel drainage edge that runs along the concrete parapet with the restoration area that includes the hill slopes up to the restaurant (2018)**

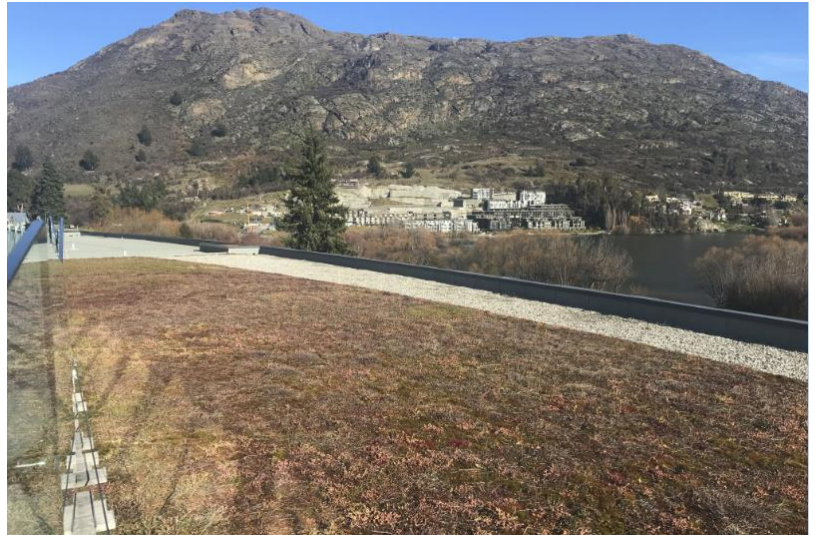
- Approximately 825m<sup>2</sup> integrated with adjacent decks.
- Plants: locally sourced (non-native) sedums and thyme.
- Medium: 60 mm deep, light-weight, pumice-based mix.
- A 50 cm to c. 2 m wide drainage band of local, rounded pebbles.
- Access: via locked gates from the decks. Metal railing and glass barriers prevent student access.

The green roof was built in September 2010. Plugs of succulent sedums and thyme were supplied and planted into the 60mm planting media by GreenRoofs Ltd<sup>5</sup>.

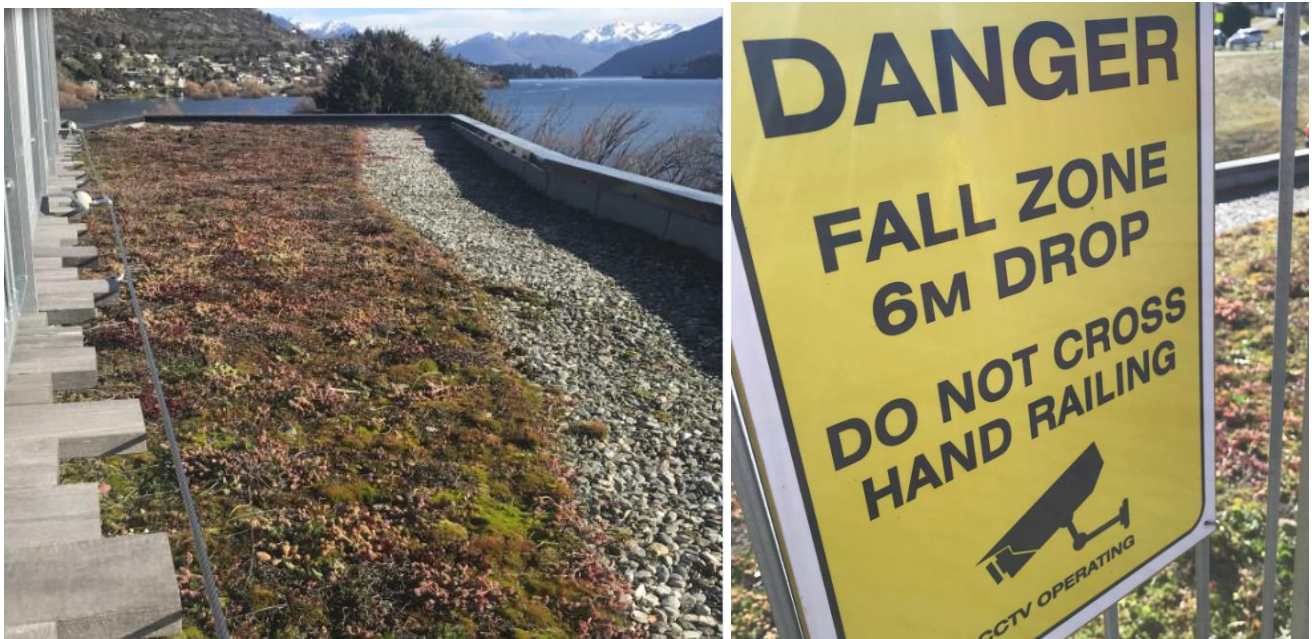
**Remarkables School decking with safety cable, sedum carpet and adjacent pebbled drainage strip which also minimises maintenance near the edge. Warning signs, locked gate and camera surveillance are used to discourage roof access.**

The roof has a low level of maintenance. The sedums die-back during winter but start growing in late spring and flower prolifically in spring and summer. "Heights" and harness training certifications are required for anyone accessing the roof; maintenance requires clipping onto a steel cable along the deck (see photo).

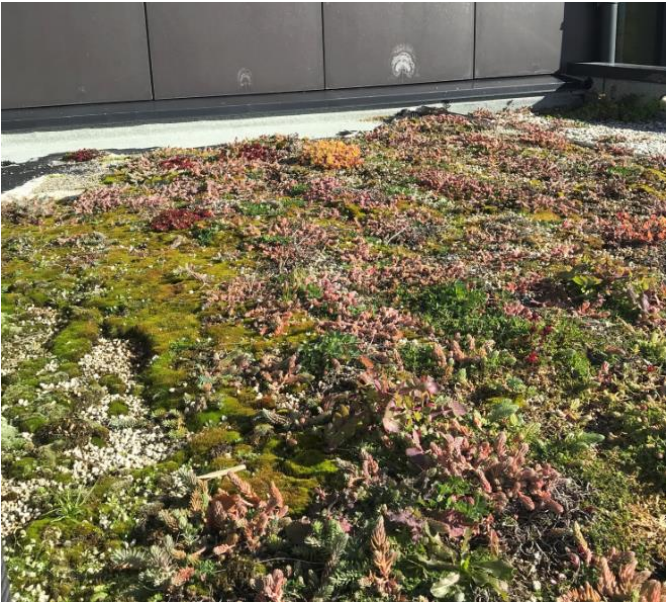
**Left:** The pale strip at the base of the wall is the waterproof membrane that has been exposed by wind-scour of the thin media. Salting of the roof may also have had an effect. **Right:** Bright-green mosses have established in some places and are very tactile.

There is no specific post-establishment assessment. Such assessments help identify reactive maintenance needs specific to living roofs, and how to rectify common issues. For example, treatment of wind-scoured areas and exposed areas of membranes, and removal of sedums from specific areas of drainage.
