Activating water sensitive design for New Zealand

ALBANY, AUCKLAND FIELD WALK

WSUD walk: Albany

WSUD Albany Sites visited

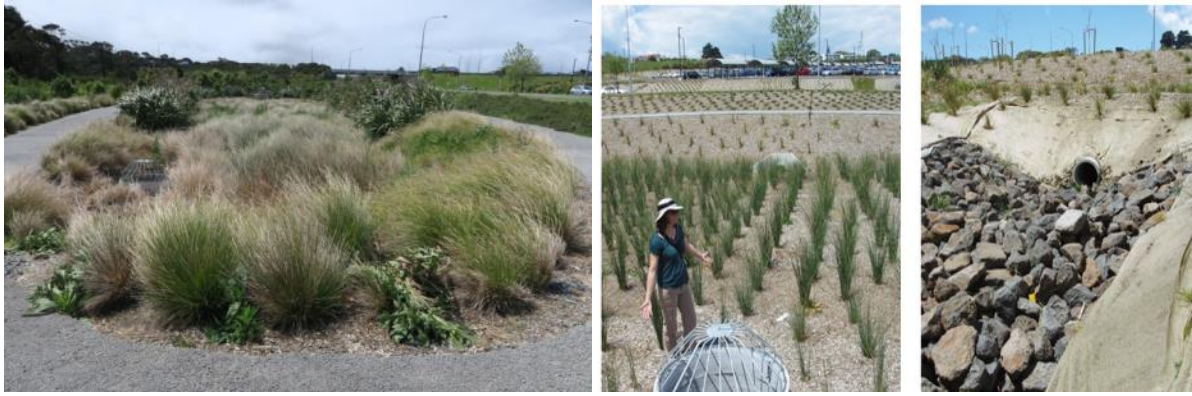
Albany park and ride station large raingarden (part of treatment train). Right photos are from 2012 and show overflow and rock-lined outlet structures

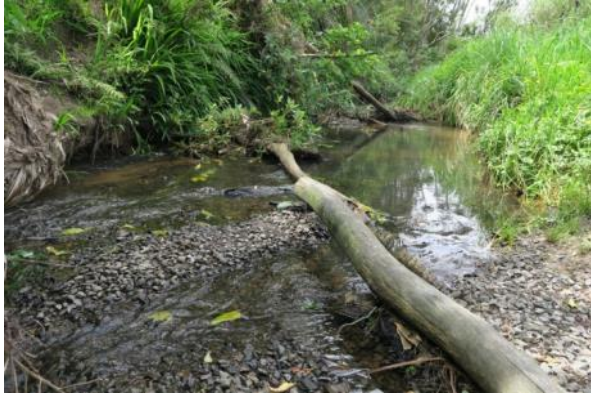
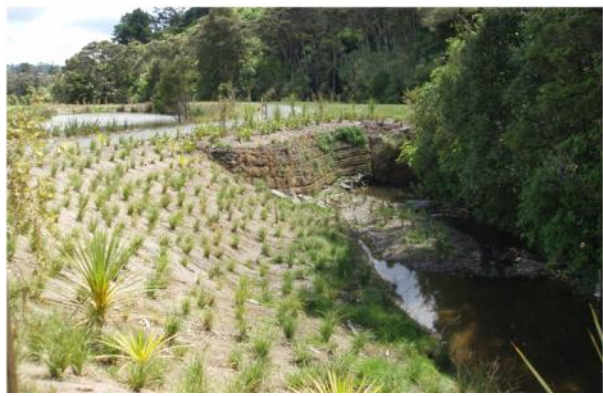
Lucas Creek reshaping of flood zone and riparian area to reduce erosion/bank instability by increasing floodplain width, adding habitat features (right photo is 2012)
